KAEFER Insulated Pipe Scan

KAEFER's Insulated Pipe Scan system (KIPS) is a portable, hand-held real-time radiographic imaging system that can look through insulation to determine the condition of the underlying pipework.

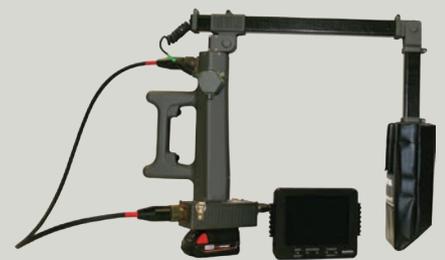
- > It allows rapid testing of insulated pipe, covering up to 250m per day.
- > KIPS can be used on pipes ranging from 20mm to 500mm with an insulation range between 10mm and 150mm.
- > KIPS can be used on: fibreglass; mineral wool; closed and open cell foam injection; PUR and PIR; and fireproofing materials such as asbestos, Chartek and Fendolite.

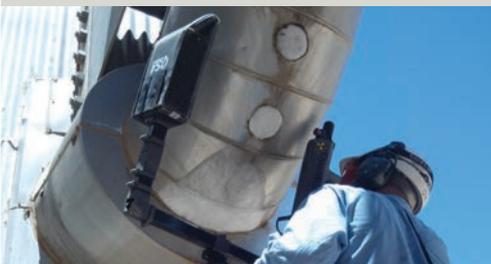
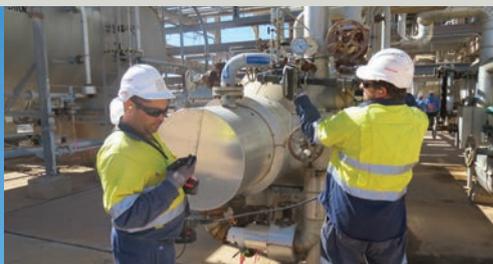
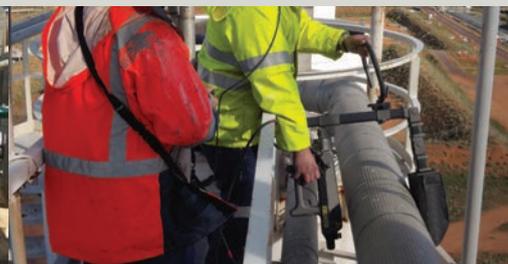
Zone 1 140-HM-327-CBE-01; Zone 2 150-HM-1535-CBE-01	
Photo 1. Area Photo	Photo 2. Zone 1 KIPS Scan Shot
Photo 3. Zone 1 Insulation Removed Shot	Photo 4. Zone 2 KIPS Scan Shot
Comment: Insulation removed, heavy scale, have not removed scale	Comment: Severe CUI filling most of the lagging area

KAEFER INSULATED PIPE SCAN REPORT ON A PAGE		KAEFER
Plant Area: Perth Convention Exhibition Centre	Report No: AOG02/17/WA/PER/K IPS-RTR	Pipe Identifier: Hot Oil System

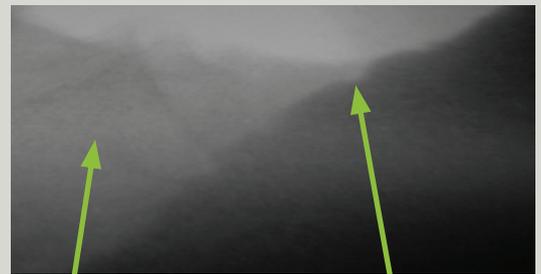
Image sample

Moisture

Corrosion under insulation
